SAP008“Extended Community Climate Change Project-Flood (ECCCP-Flood)”

Quarterly Environmental and Social Safeguards Monitoring Report

July 2023-September 2023

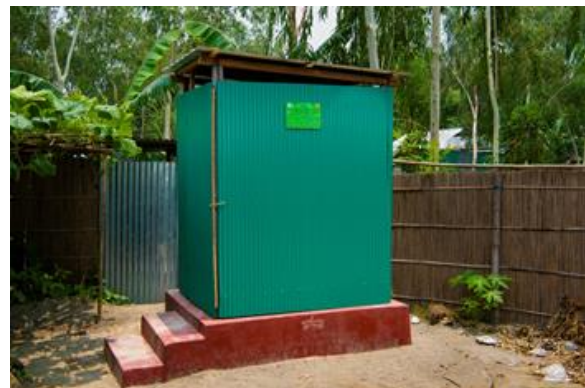
Figure 2: Flood resilient Sanitary Latrine

A considerable number of tube-wells and latrines have been installed successfully, with effective management systems in place for wastewater. Wastewater is directed into soak wells to prevent groundwater contamination. Household and livestock waste, along with wastewater, are channeled through earthen channels and deposited in designated areas and rings. The proximity of water bodies to project sites ensures that construction waste and wastewater do not pose a risk of surface water contamination. No major community health, safety, or security issues have been reported to date.

A substantial number of tube-wells and latrines have been successfully installed, and effective management systems are in place for the wastewater generated. Wastewater is directed into soak wells, ensuring uncontaminated groundwater. Household and livestock waste, along with wastewater, are guided through earthen channels and deposited in designated areas and rings. The proximity of water bodies to the sub-project sites ensures that construction waste and wastewater do not pose a risk of surface water contamination. No major community health, safety, or security issues have been reported to date.

Project participants have exhibited commendable hygiene practices, such as wearing sandals or slippers when using latrines. The project locations are well-equipped with water tanks and soap for maintaining hygiene, and the surroundings of the latrines are kept clean and orderly.

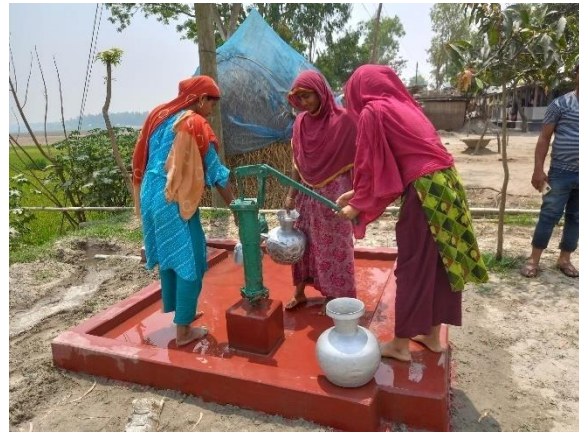
Figure 3: Flood resilient Community Tubewell

Ensuring the availability and quality of drinking water has presented a notable challenge for implementing entities in char (riverine island) areas. To address water-borne diseases, deep tube-wells have been installed in most clusters, with additional installations planned in the coming months. Guidance from the Department of Public Health and Engineering (DPHE) was followed for tube-well placement, maintaining a minimum

distance of 30 feet between tube-wells and latrines, except in specific areas of Lalmonirhat, Jamalpur, and Nilphamari districts. Rigorous laboratory testing of water quality, particularly iron (Fe) and arsenic (As) levels, has been undertaken before declaring tube-well water safe for drinking. Some water samples are currently undergoing testing, and as of now, no arsenic contamination has been detected (according to Bangladesh standards). However, in a few locations in Gaibandha, iron concentrations exceeded the standard limits. Tube-well platforms have been constructed with appropriate slopes to facilitate efficient water drainage in most areas.

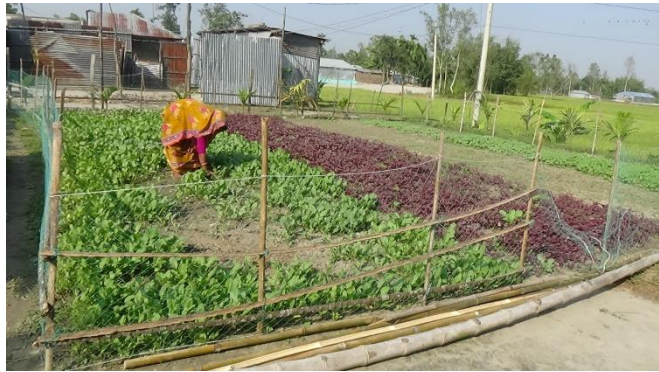
Figure 4: Practicing Homestead gardening

As of now, there are no identified threats to biodiversity arising from the project. The project explicitly avoids introducing invasive alien species, and the planting of trees on elevated plinths around homesteads is contributing to the preservation of natural resources.

Although a few trees were cut during plinth-raising activities, the positive practice of planting three trees in place of one has been implemented to maintain a balance between conservation and development efforts. Additionally, turfing on the plinth slopes and active engagement in homestead gardening by project participants further contribute to environmental sustainability.
